DAILY REPORT

PROJECT NAME: Old Harbor Small Boat Harbor Installation

CONTRACTOR: West Construction

DATE: January 23, 2010

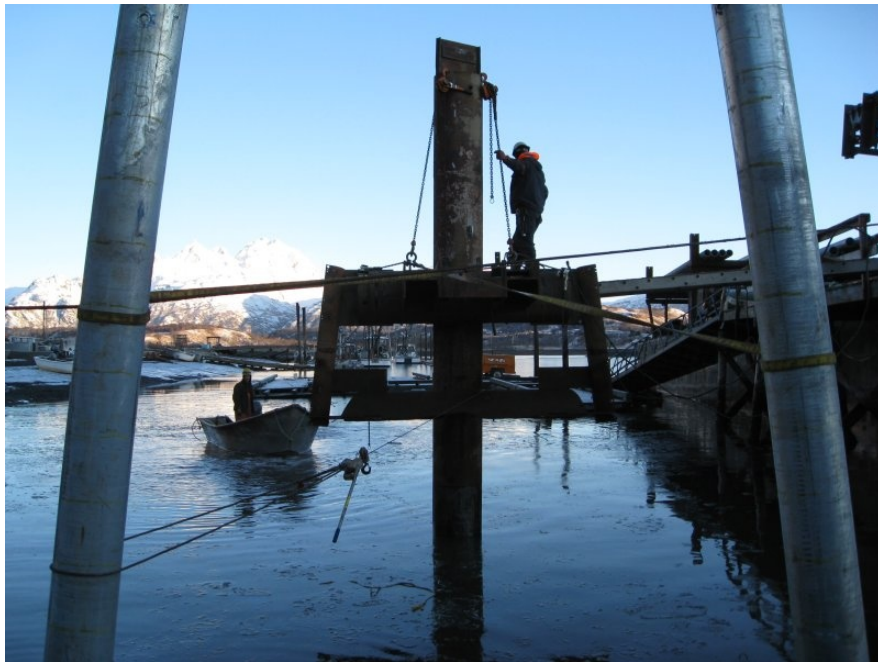
Image 1: Setting template in place for bent #5

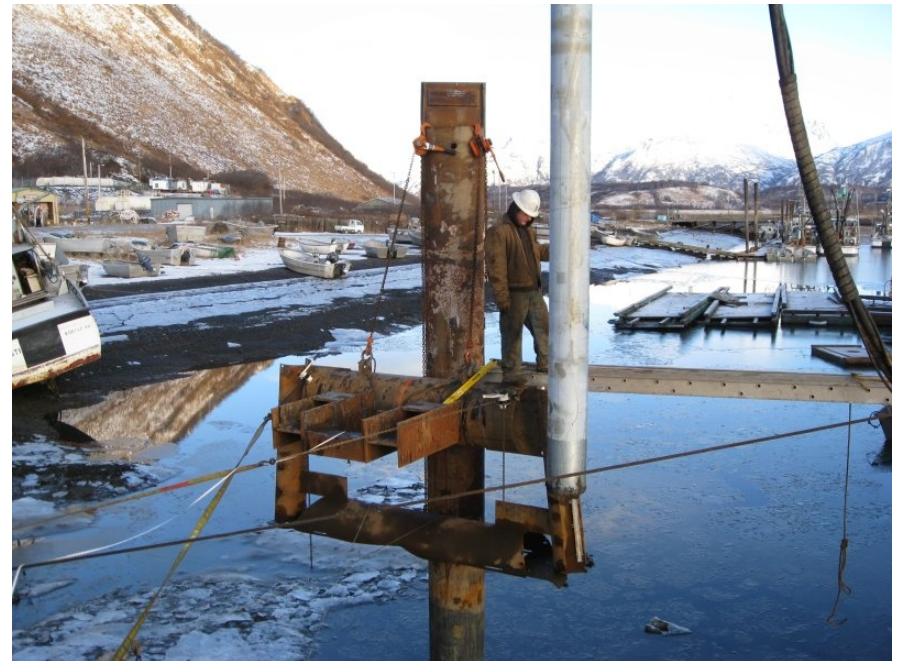
- 11:33 AM
 - Pile 10S driven, several hard layers encountered between mudline and 17' embed.
- 11:37 AM
 - Driving on 10S stops when vibratory hammer produces no downward movement, finish at 17.5' embed.

- 12:04 PM
 - Driving on 10S starts
- 12:10 PM
 - Driving on 10S ends @ 32.5' embed.
- 12:13 PM
 - Driving on 9N starts

Image 10: Setting pile 10S into template

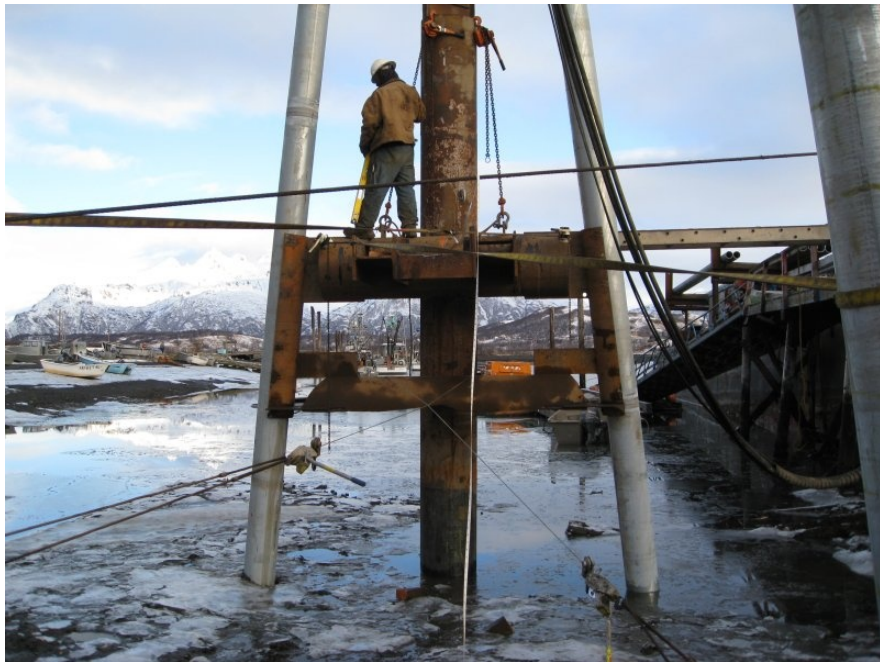
- Pile 9N picked and placed
- 11:47 AM
 - Driving on 9N stops on hard layer at similar depth as 10S, around 17' embed.
- 11:58 AM
 - Impact hammer picked, placed on pile 10S

Image 11: Setting pile 9N into the template

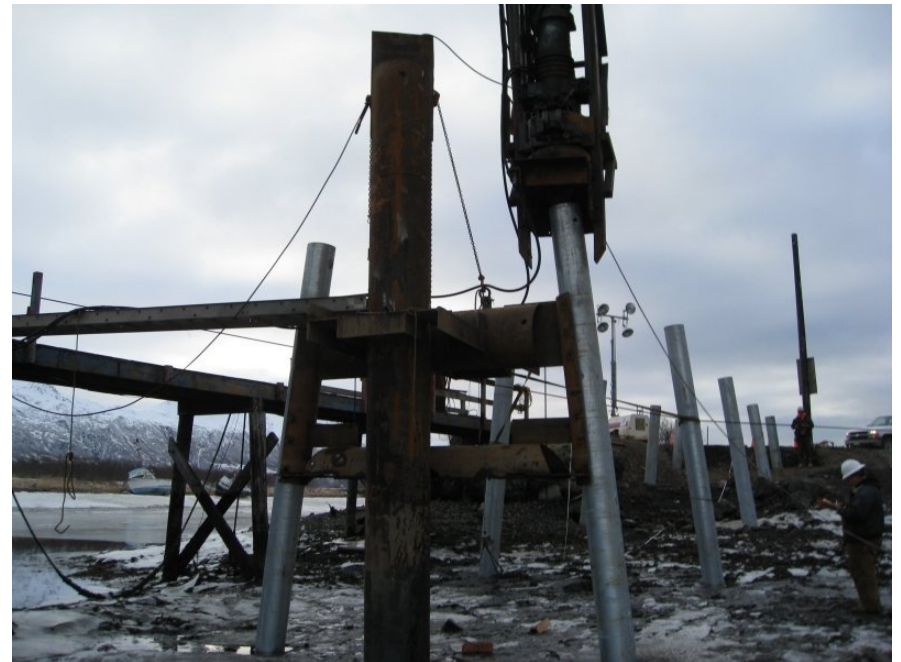
- 12:25 PM • Driving on 9N ends @ 32.5' embed.
- 12:30 PM • MDS walks down to proposed city dock location to photograph and take video.
• Briefly examined existing timber city dock, photographed fuel headers, and condition of deck. Did not go underneath dock.

Image 12: Finished driving pile 9N

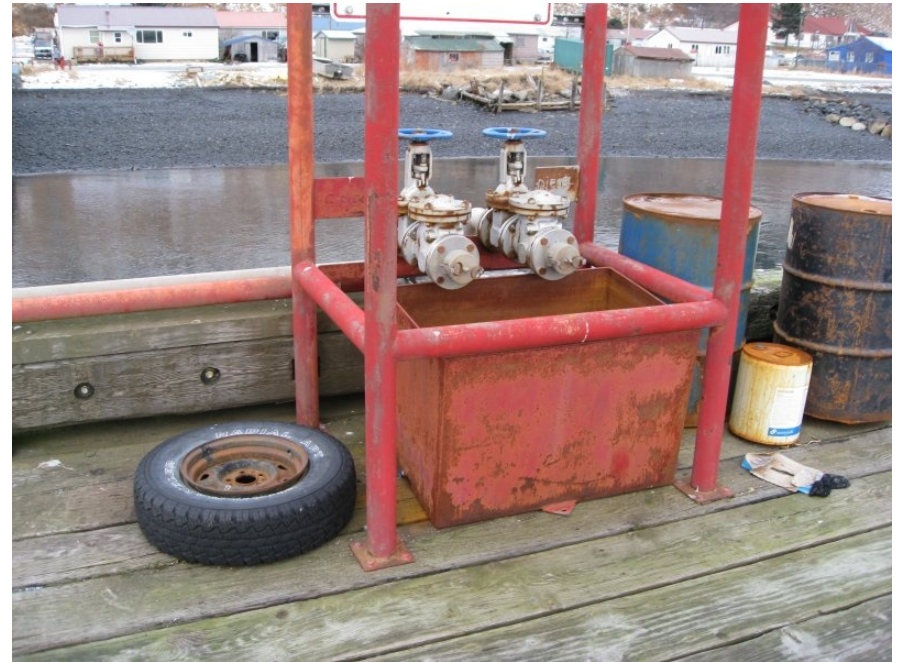
Image 14: Fuel headers at existing City Dock

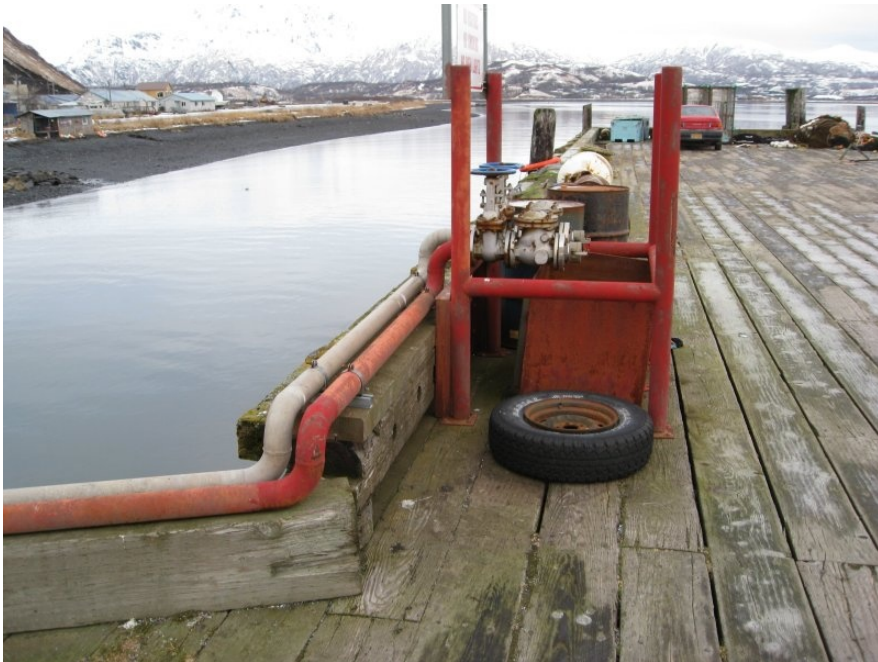
Image 15: Fuel headers at existing City Dock

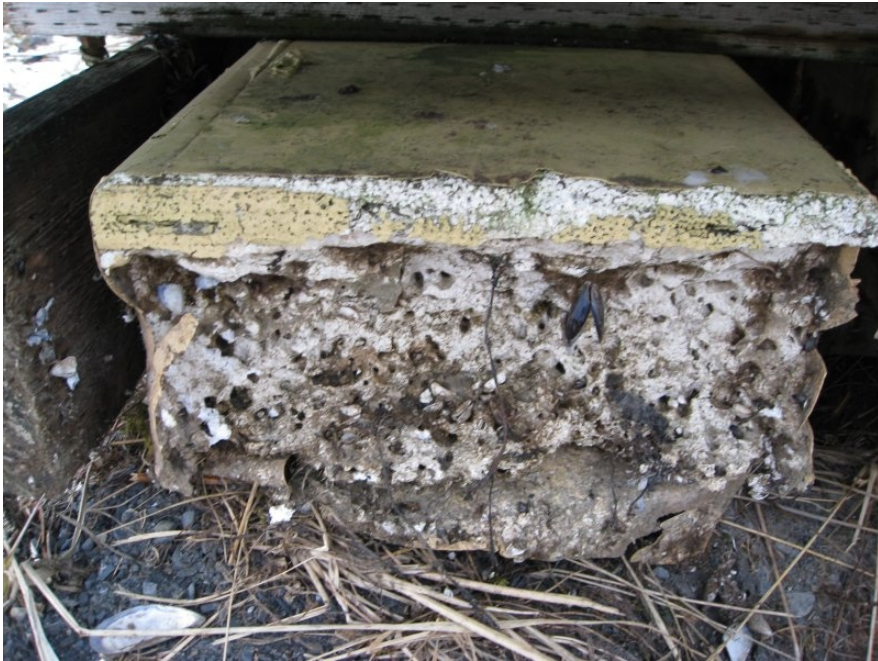
Image 17: Flotation billets from old floats, showing damage.

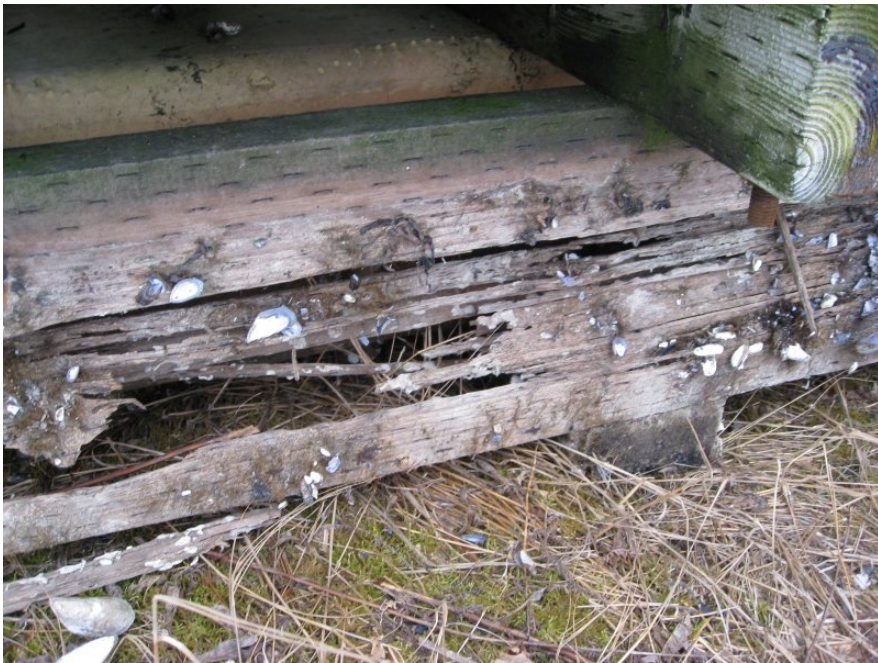
Image 20: Pressure treated side boards damage on old floats.

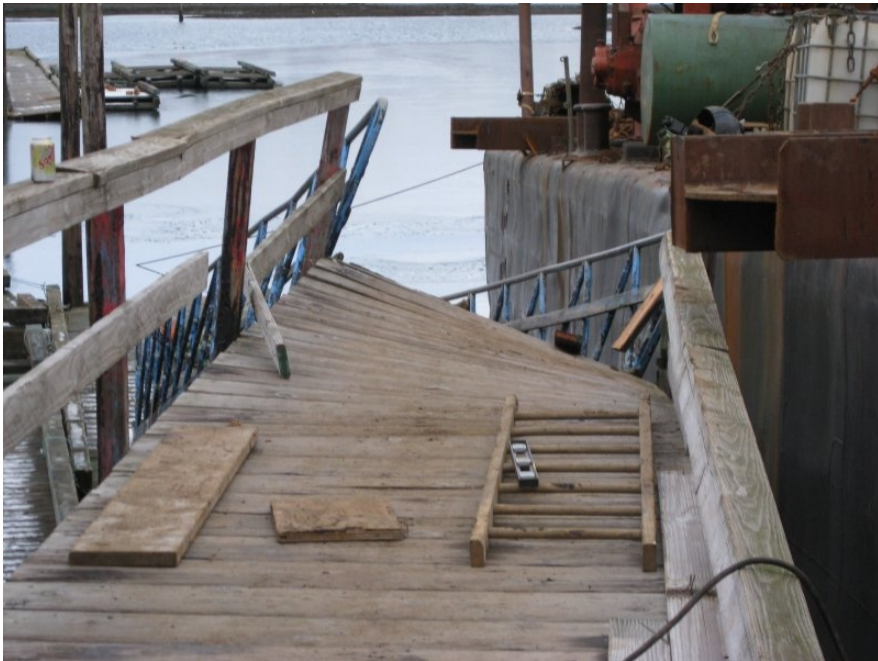
Image 23: Barge damaged old trestle while being repositioned

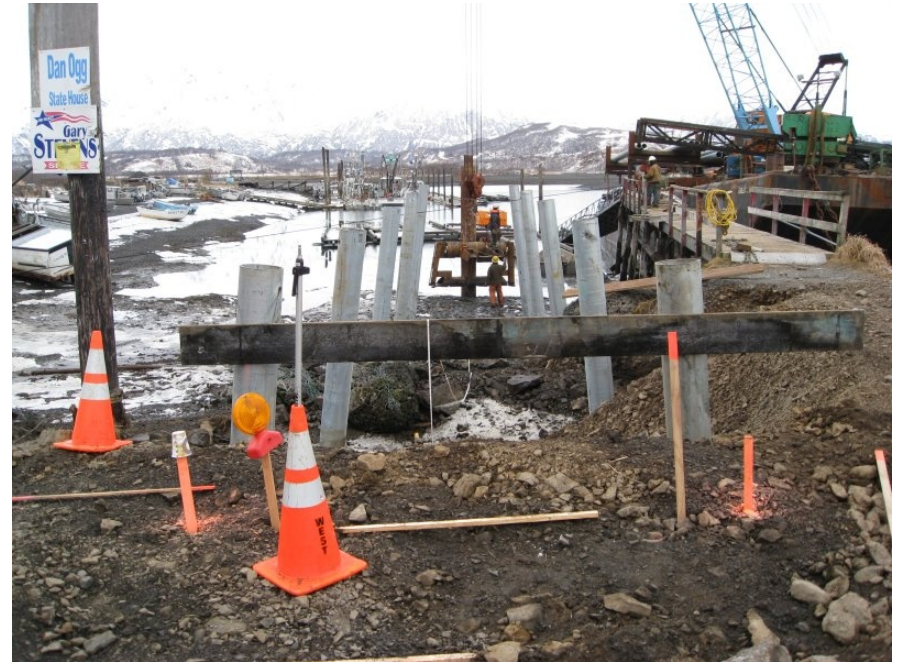
• To make 14.4' cutoff, 18" of pile were removed, which gives us a tip elevation of -31'
- 02:15 PM • Pilebucks have difficulty with template, bent #6 appears to be installed 1" shoreward of design location.

Image 22: Setting the template for Bent #6

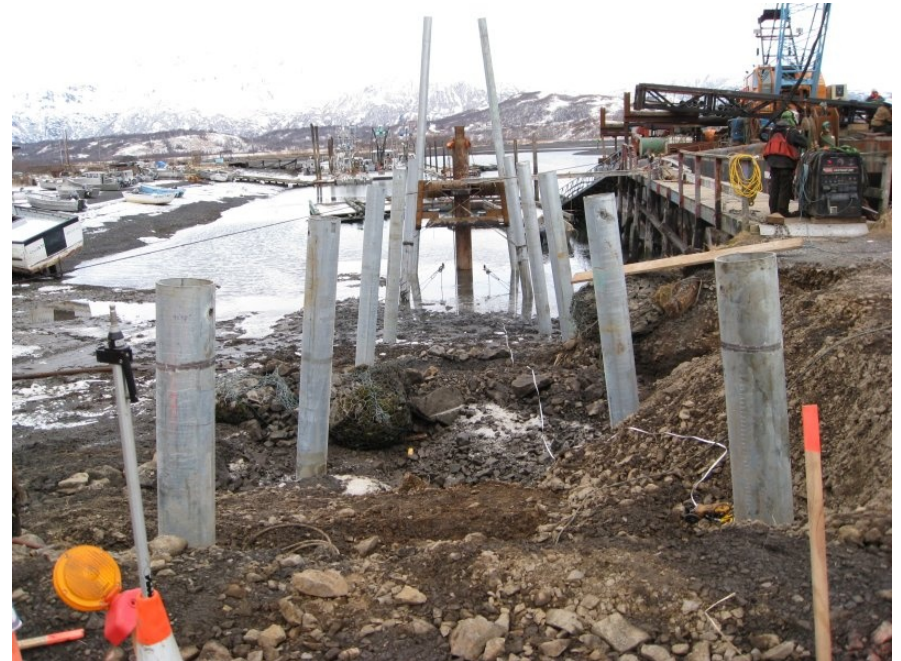
- 03:00 PM • Template finished, vibratory hammer in leads
- 03:15 PM • Pile 11N vibed into place, Stop driving in very hard layer at 16' embed.
- 03:21 PM • Pile 12S vibed into place, stop driving in very hard layer at 16' embed.

Image 24: Piles 11N and 12S in place in the template

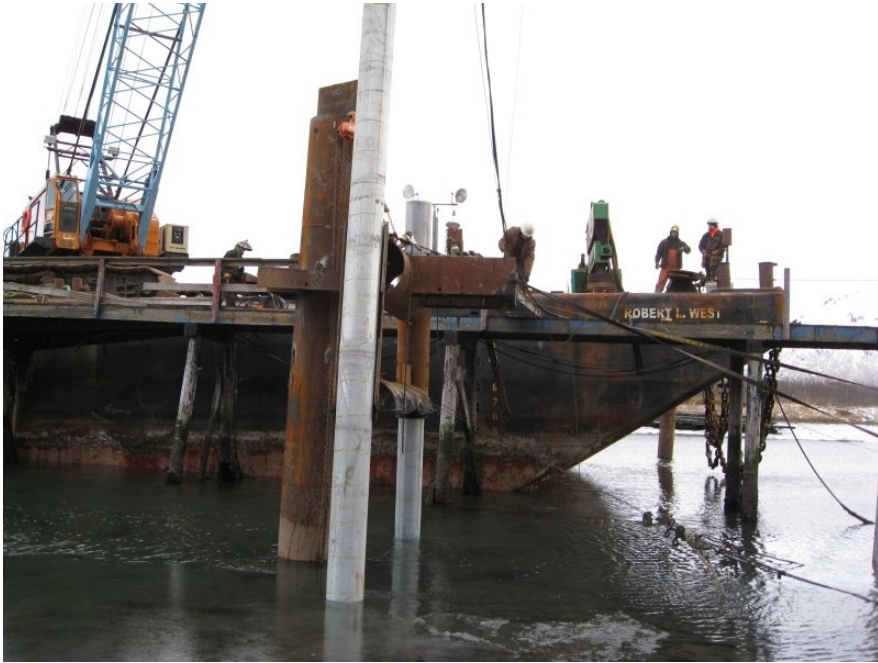
- 03:30 PM • Impact hammer picked, and ready.
- 03:40 PM • Driving starts on pile 12S
- 03:44 PM • Driving ends on pile 12S, embed. depth is 33'
- 03:45 PM • Driving starts on pile 11N

Image 25: Pile 12S driven

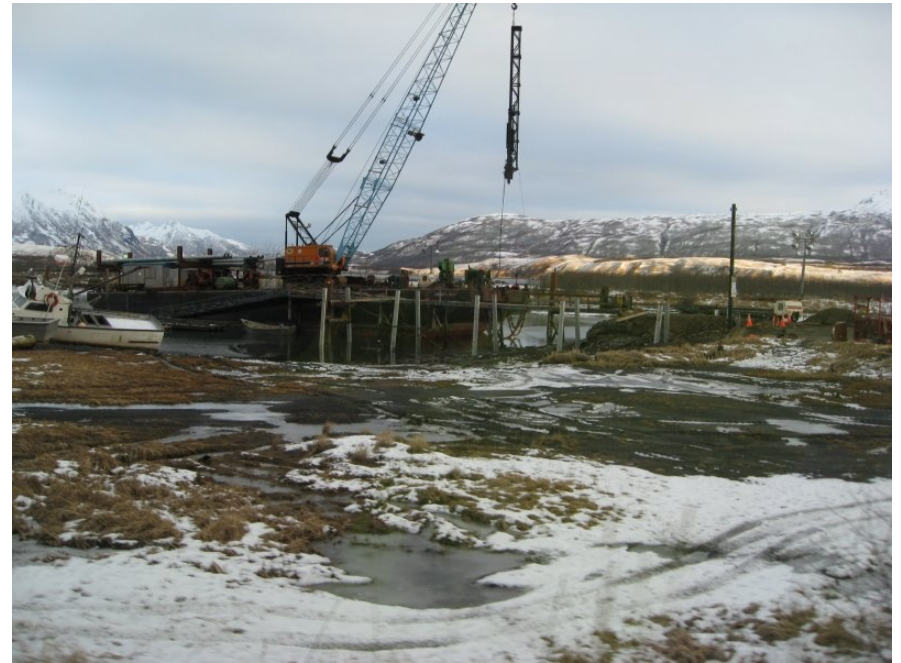
- 03:57 PM • Driving ends on pile 11N, embed. depth is 33.5'
- 04:00 PM • Drive back to Lodge, pack bags, call Island Air, drive to airport
- 04:20 PM • Island Air flight leaves Old Harbor for Kodiak.

Image 26: Leaving jobsite after driving pile 11N
